## Common Flooring Problems Observed by Cornerstone Flooring at various Plant Audits

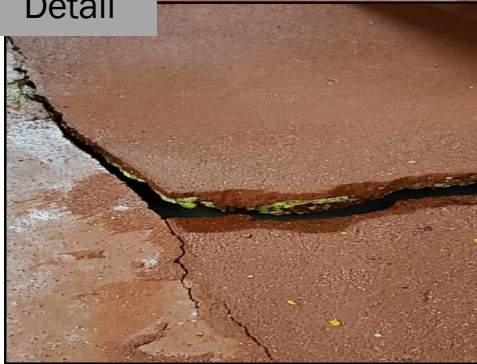
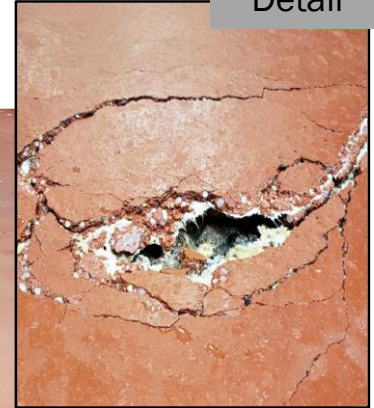
## Problem: Floor Toppings that are delaminating

Examples of existing flooring toppings that are cracking and delaminating, creating potential harborage points.

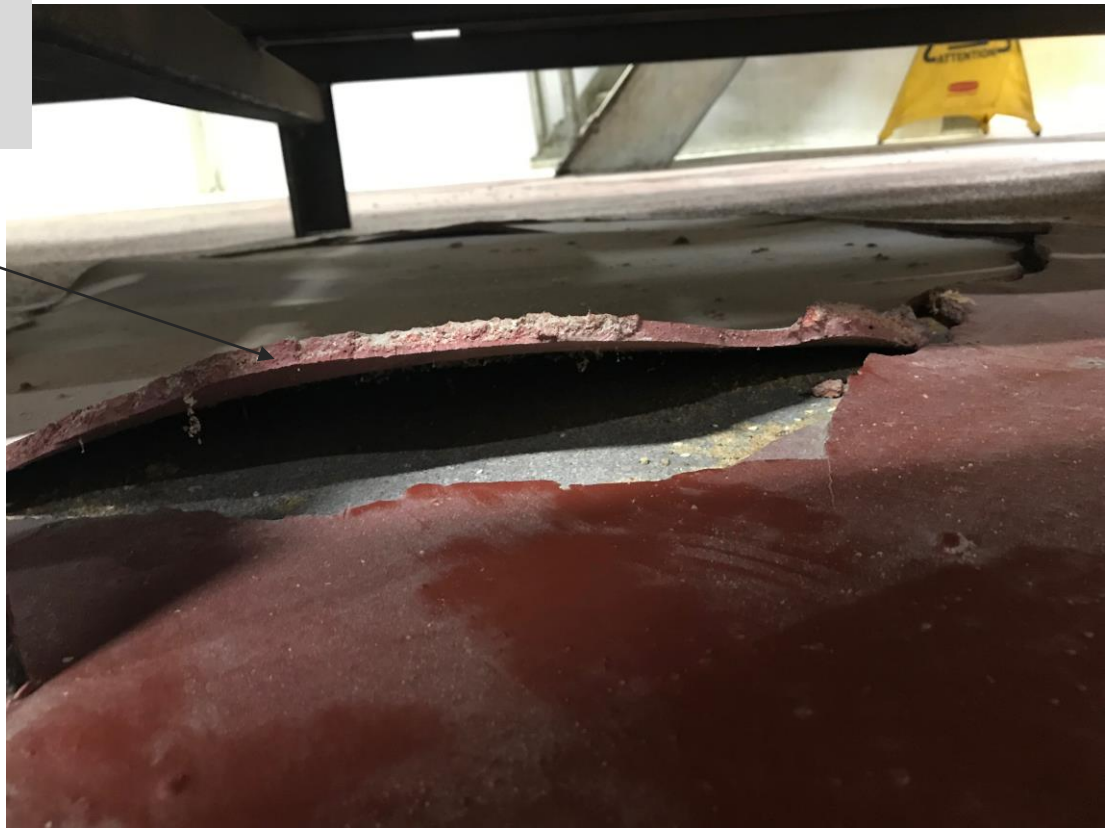
## Problem: Floor Toppings that are delaminating

Additional examples of existing flooring toppings that are cracking and delaminating, creating potential harborage points.

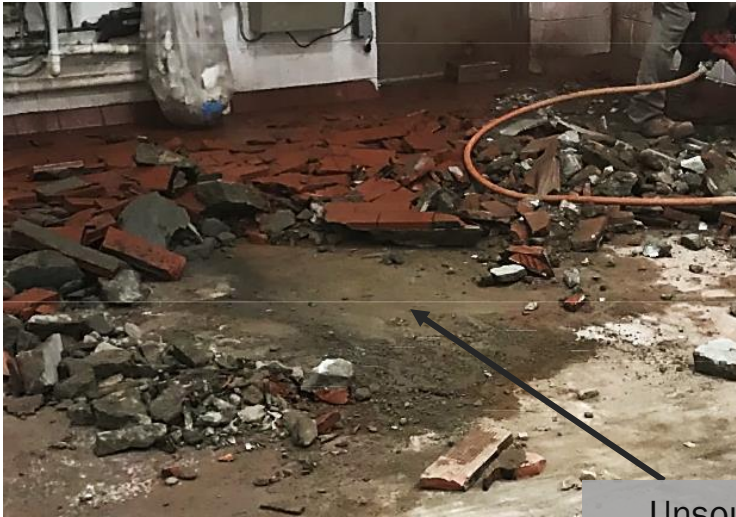
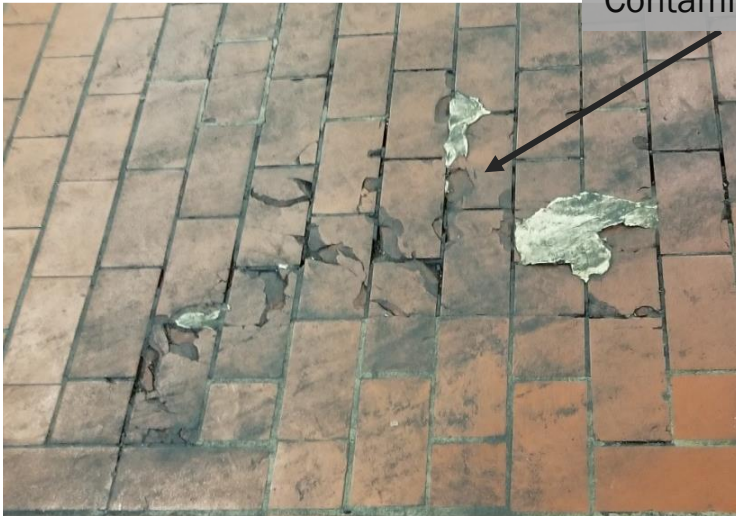
## Problem: Unsound Brick and Contaminated Grout Bed

Unsound Brick and  
Contaminated Grout Bed

Flooring Installed  
over unsound Brick

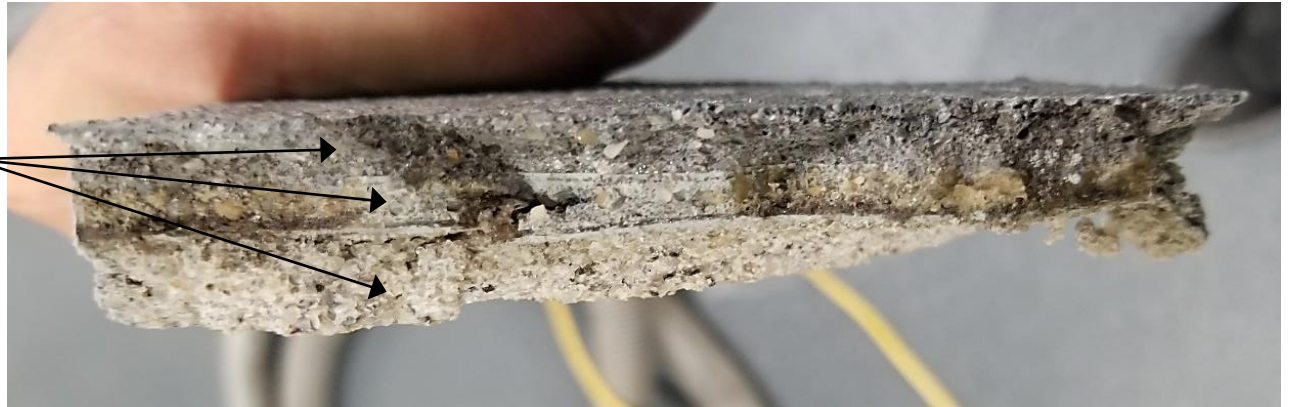
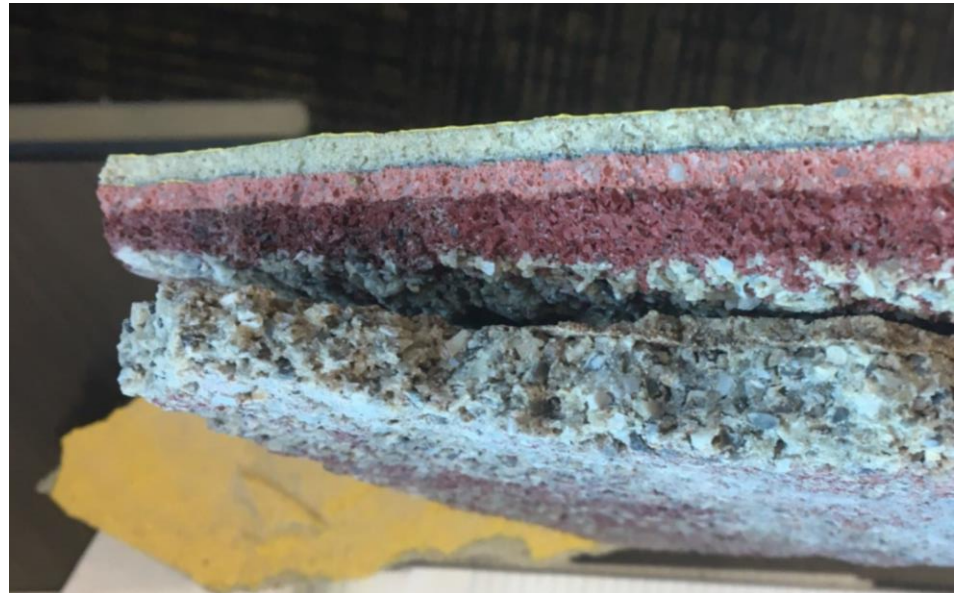
Problem: Installing a new floor over an existing one.

Evidence of multiple layers  
of epoxy floors failing.

It is important to remove existing floors to the structural slab.

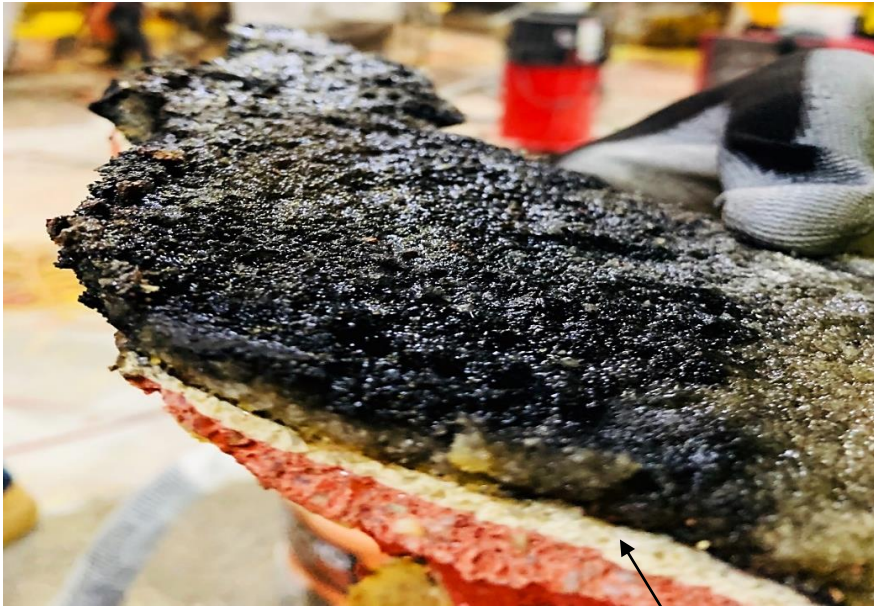
Problem: Installing a new floor over an existing one.

Evidence of multiple layers of epoxy floors failing.

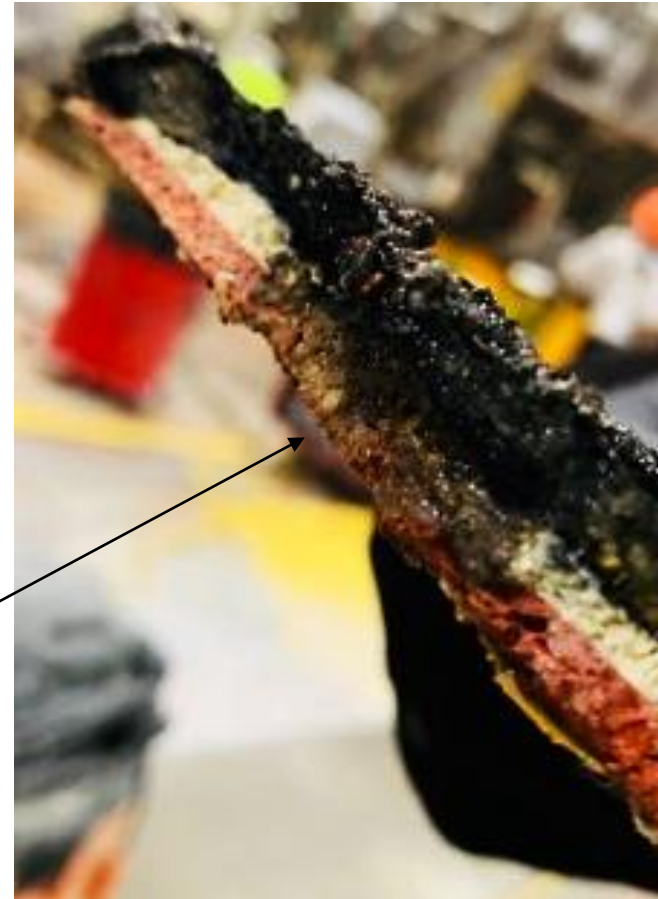
Evidence of mold and bacteria growing in between layers of epoxy flooring that a competitor installed.

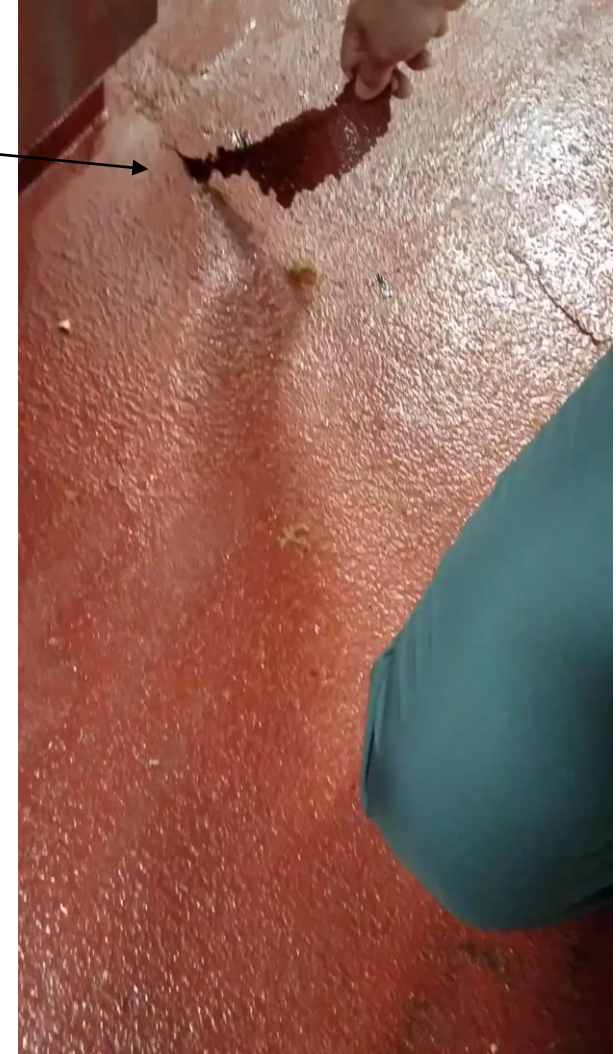
## Problem: Installing a new floor over an existing one.

Epoxy coating is delaminating from the substrate. Many of Cornerstone's competitors continue to apply an epoxy topcoat over cementitious urethanes.

It appears a competitor removed loose sections of existing floor and coated over remaining layers with epoxy topcoat.

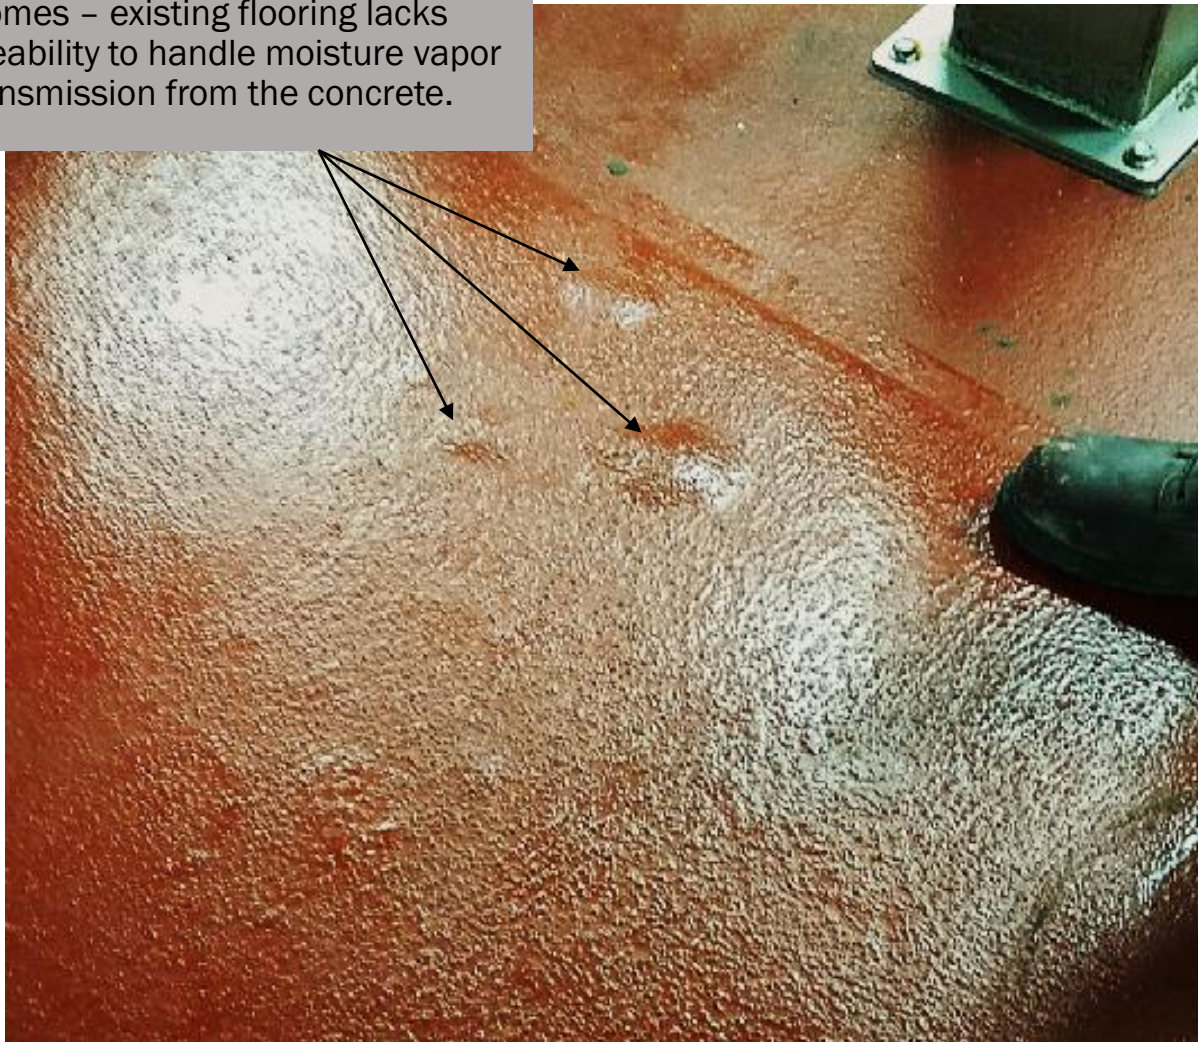
## Problem: Moisture Vapor Transmission

Domes – existing flooring lacks permeability to handle moisture vapor transmission from the concrete.

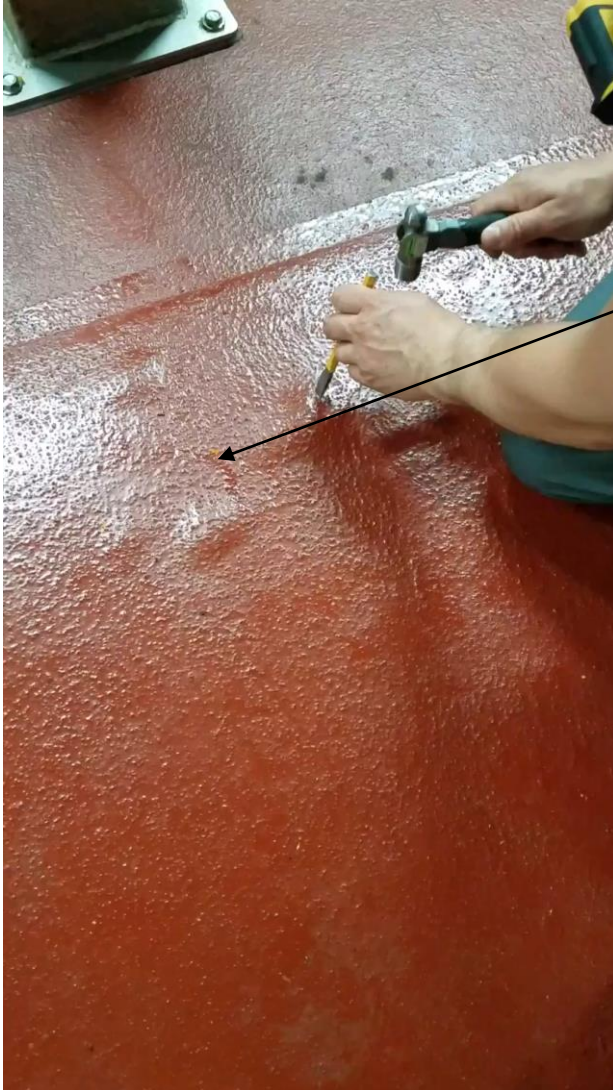
## Problem: Moisture Vapor Transmission

High alkalinity due to moisture vapor transmission from the concrete. This is attacking the epoxy, creating these domes.

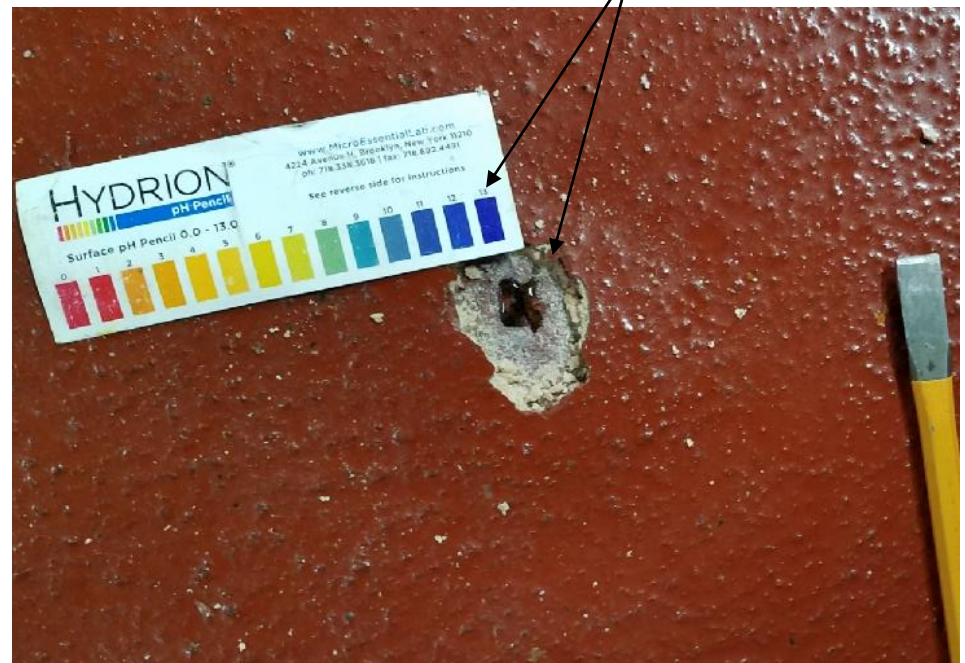
High alkalinity due to moisture vapor transmission from the concrete. This is attacking the epoxy. pH is 13+ as shown.

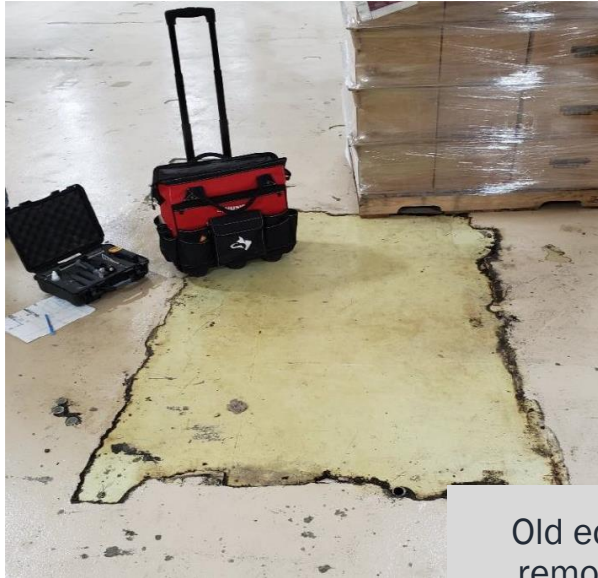
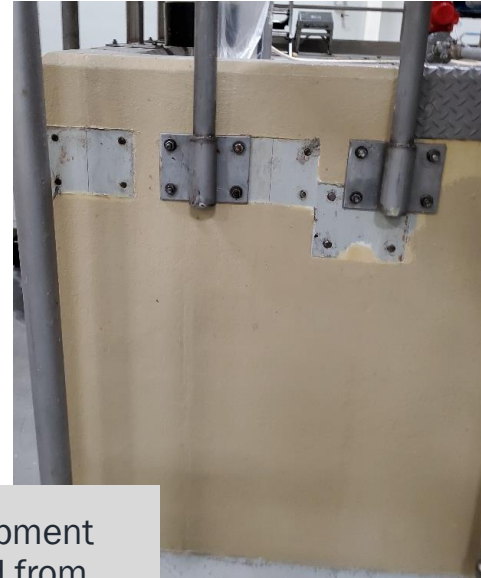
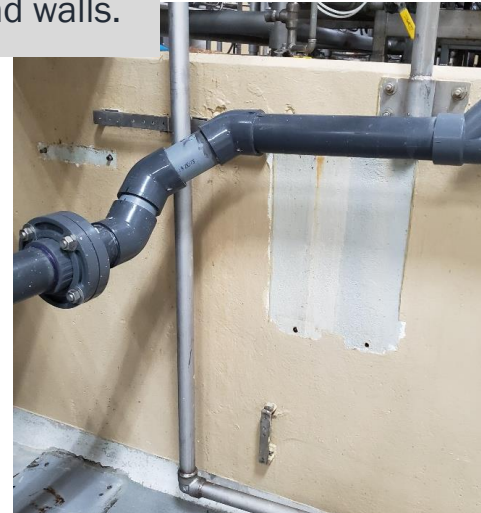
## Problem: Old equipment was removed, Floors and Walls

Old equipment  
removed from  
flooring and walls.

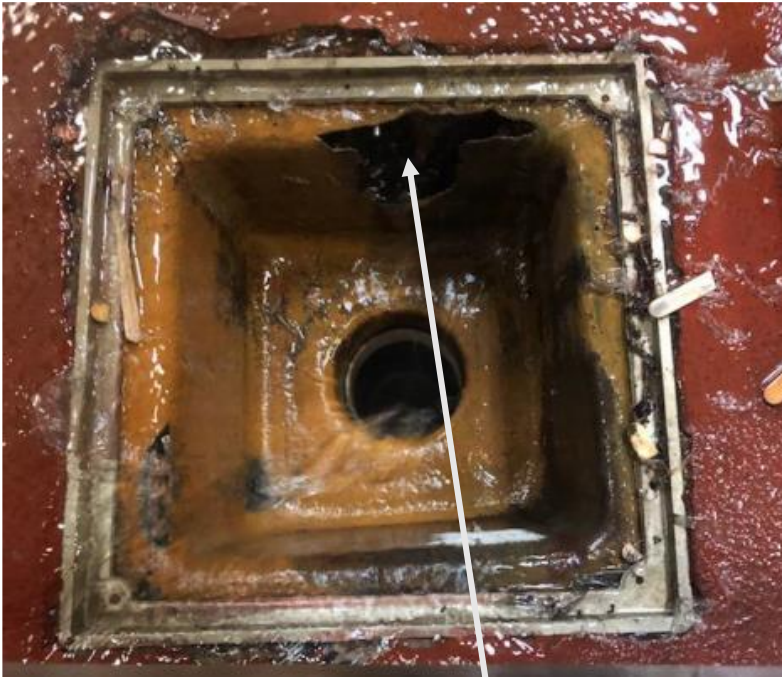
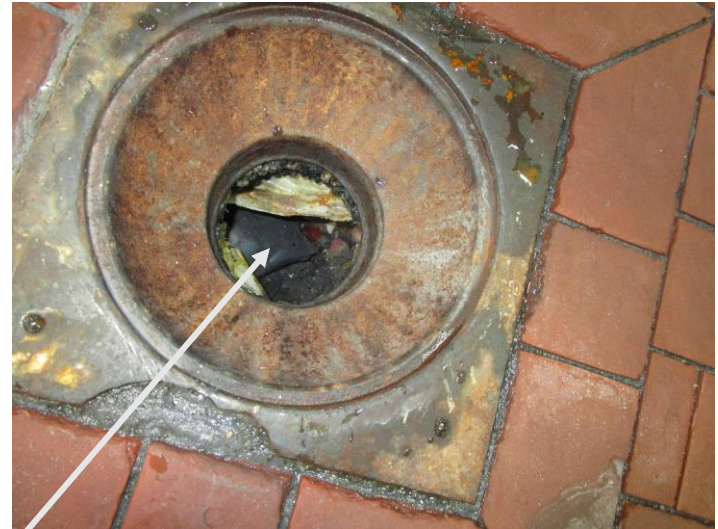
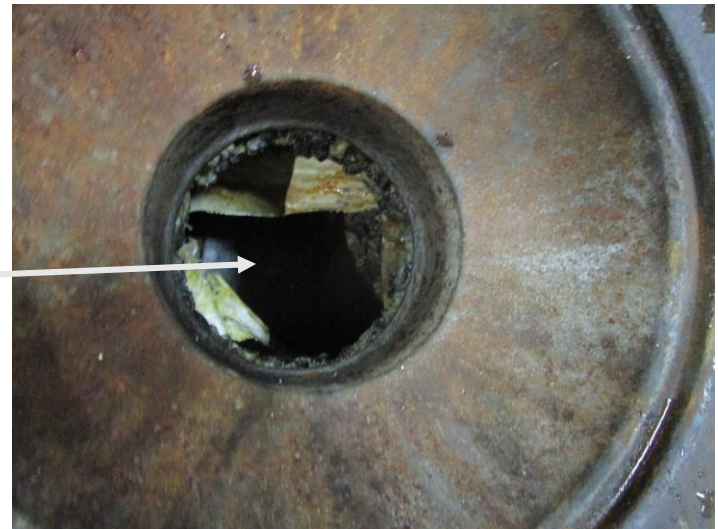
## Additional Problem: Failing Drains

Failure in drains  
allowing contaminants  
to leak into substrate.

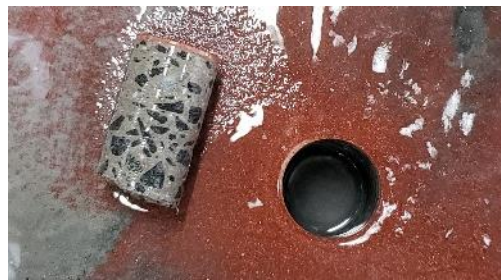
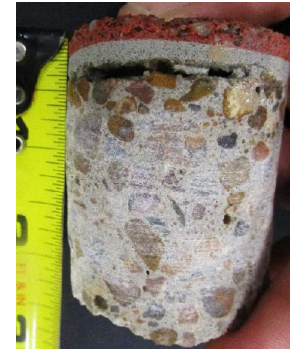
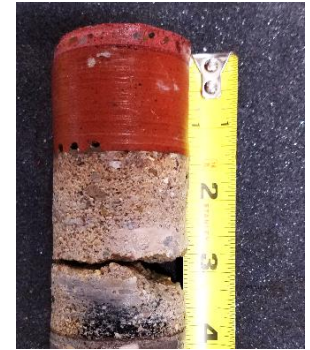
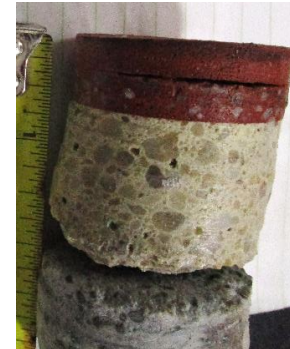
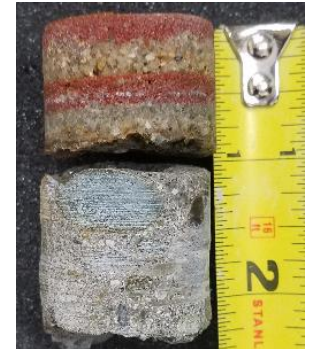
## The Coring Process

The core machine is designed to connect to a water supply to ensure no dust will be created from the coring process. After the core is removed, fast setting cement will be placed flush with adjacent floors.

A view of the floor system matrix, including all surfaces above structural slab used to determine preparation and replacement steps.
