CORNERSTONE[®]
FLOORING

Sanitary Design Benefits of Anti-Microbial Flooring & Wall Systems

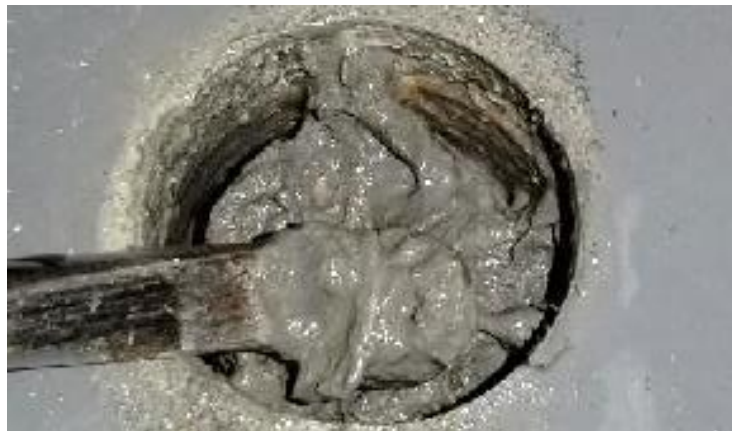
Water below the surface is eating away at the existing epoxy floor. This paste of decomposing epoxy was hiding underneath.

Why Epoxies Fail

The coefficient of expansion for epoxy resin systems typically differs from the concrete substrate by 50%. Therefore where thermal shock and fluctuating process temperatures are involved, the epoxy matrix opens up exposing a more porous matrix.

Once the epoxy becomes open, the food product's pH and cleaning solutions will penetrate the epoxy screed and attack the resin's curing agent which will break down, causing the floor to debond and fail.

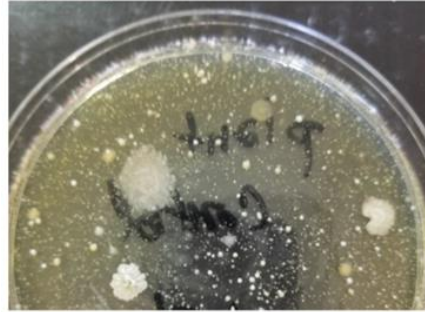
Dairy Tile Sample
234,000 cfu/ml

Samples were serially diluted with Nutrient Agar and read out as Total Plate Count. The samples were taken within 12" of each other, one of the CornerCrete SB patch and the other of the existing Dairy Tile. The results after the first production day, taken the morning after sanitation, showed a difference of over 3-log (80 cfu/ml on the CornerCrete SB Floor vs. 234,000 cfu on the Dairy Tile). Pictures to the left represent the 10-1 dilution on Nutrient Agar.

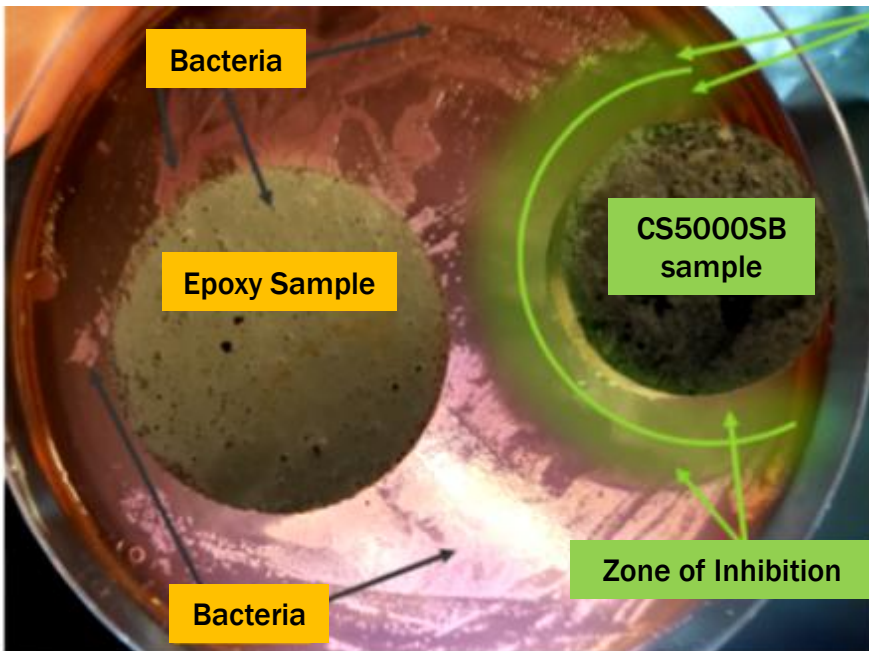
Zone of Inhibition

Bacteria is clearly visible in the areas immediately surrounding and underneath the epoxy control sample.

In an additional study, a CS5000SB floor piece and an epoxy control was tested using a spread-plate technique. The CS5000SB sample prevented the growth of bacteria immediately around and under the sample. The epoxy control allowed growth under and around the sample.

Cornerstone Flooring's Anti-Microbial flooring systems do not allow bacteria to multiply on or around the surface. The zone of inhibition (shown in green) around the CS 5000SB flooring system sample provides a visual explanation of how the area immediately surrounding and underneath the sample is not growing any bacteria.
